**AFRL-VA-WP-TR-2004-3057**

**EFFECT OF PREEXISTING  
CORROSION ON FATIGUE CRACKING  
OF ALUMINUM ALLOYS 2024-T3 AND  
7075-T6**

**Final Report for 01 February 1993 – 01 August 1995**

**AIR VEHICLES DIRECTORATE  
AIR FORCE MATERIEL COMMAND  
AIR FORCE RESEARCH LABORATORY  
WRIGHT-PATTERSON AIR FORCE BASE, OH 45433-7542**

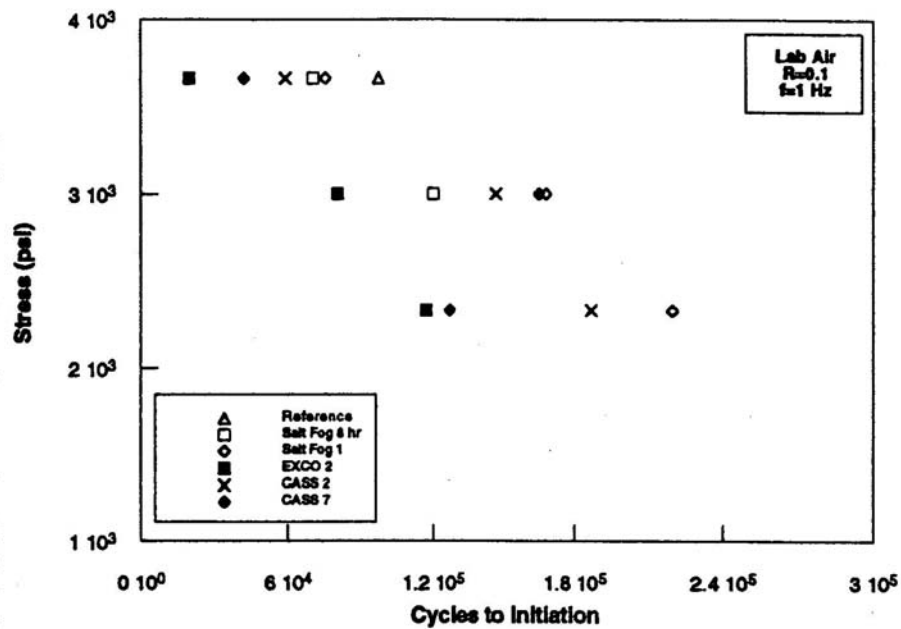
Figure 58. S-N Curves Showing Cycles to Fatigue Crack Initiation in Aluminum Alloy 2024-T3 as a Function of Stress for ECT Specimens with Different Degrees of Corrosion

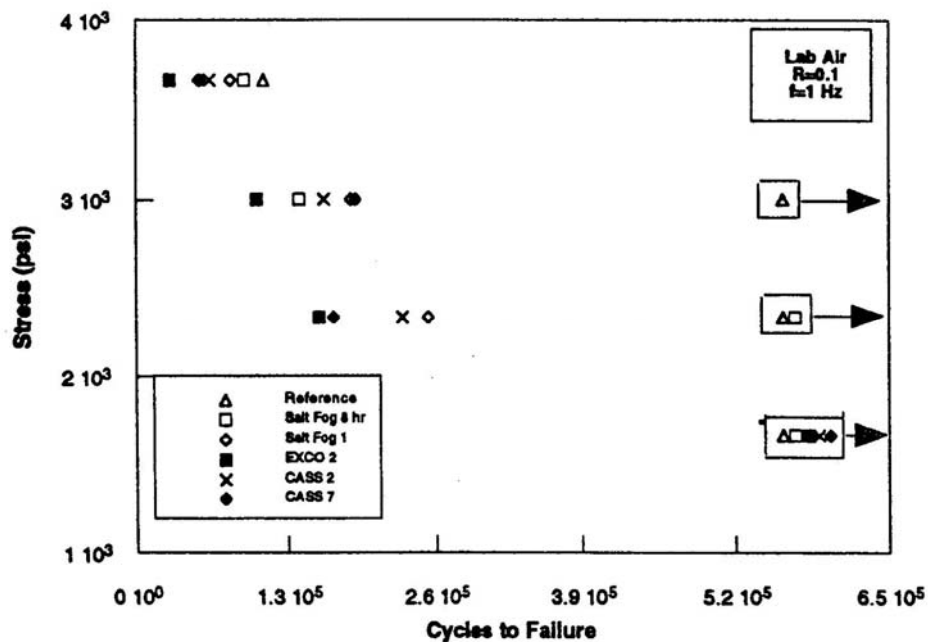
Figure 59. S-N Curves Showing Cycles to Failure of Aluminum Alloy 2024-T3 as a Function of Stress for ECT Specimens with Different Degrees of Corrosion

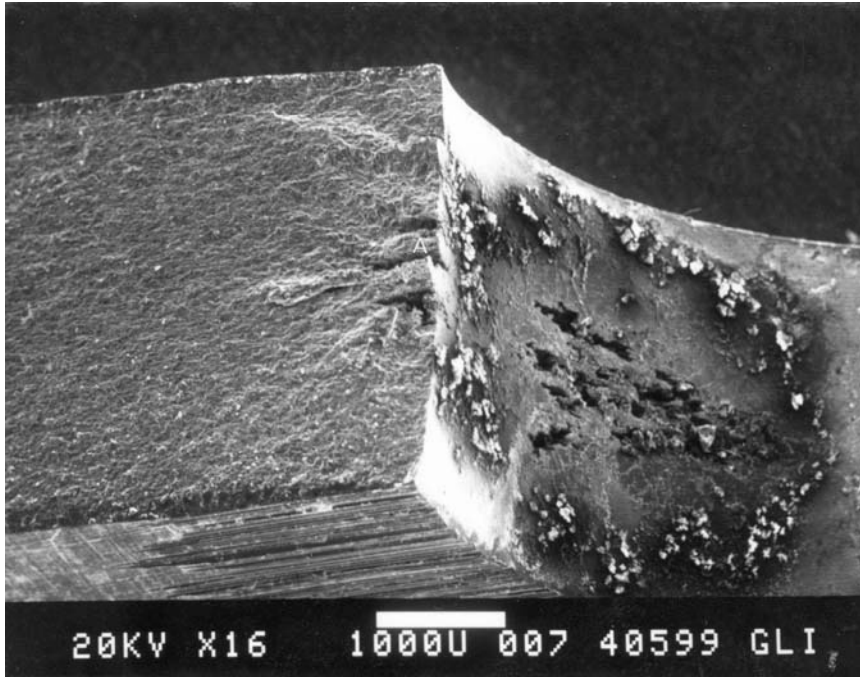
**Figure 63. SEM of Aluminum Alloy 2024-T3 ECT Specimen Pre-corroded in the CASS Environment for 7 Days and Fatigued in Laboratory Air (5 Hz, R=0.1)**

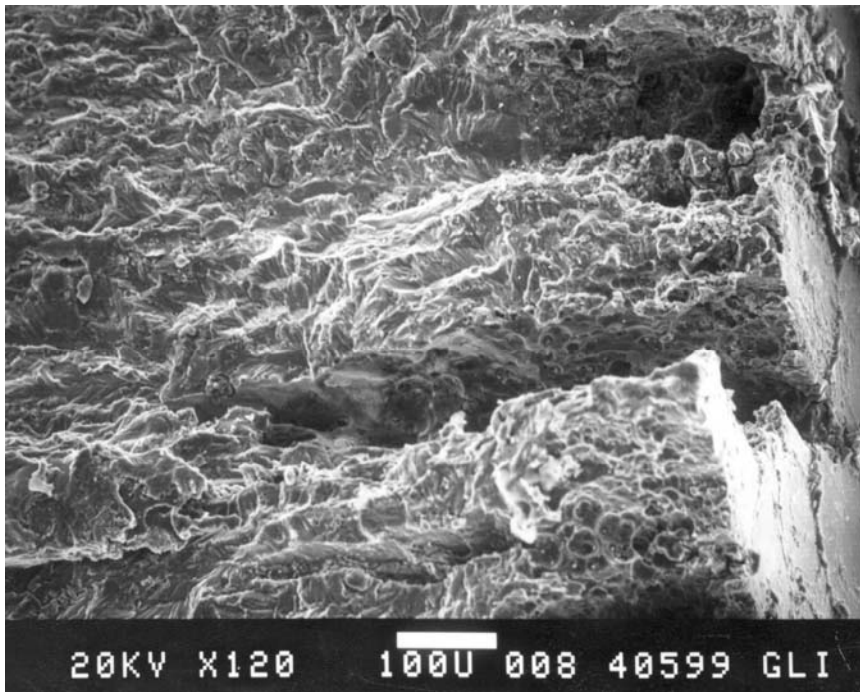
**Figure 64. Detail of Area A in Figure 63 Showing the Deep Pits from Which Fatigue Cracking Originated**

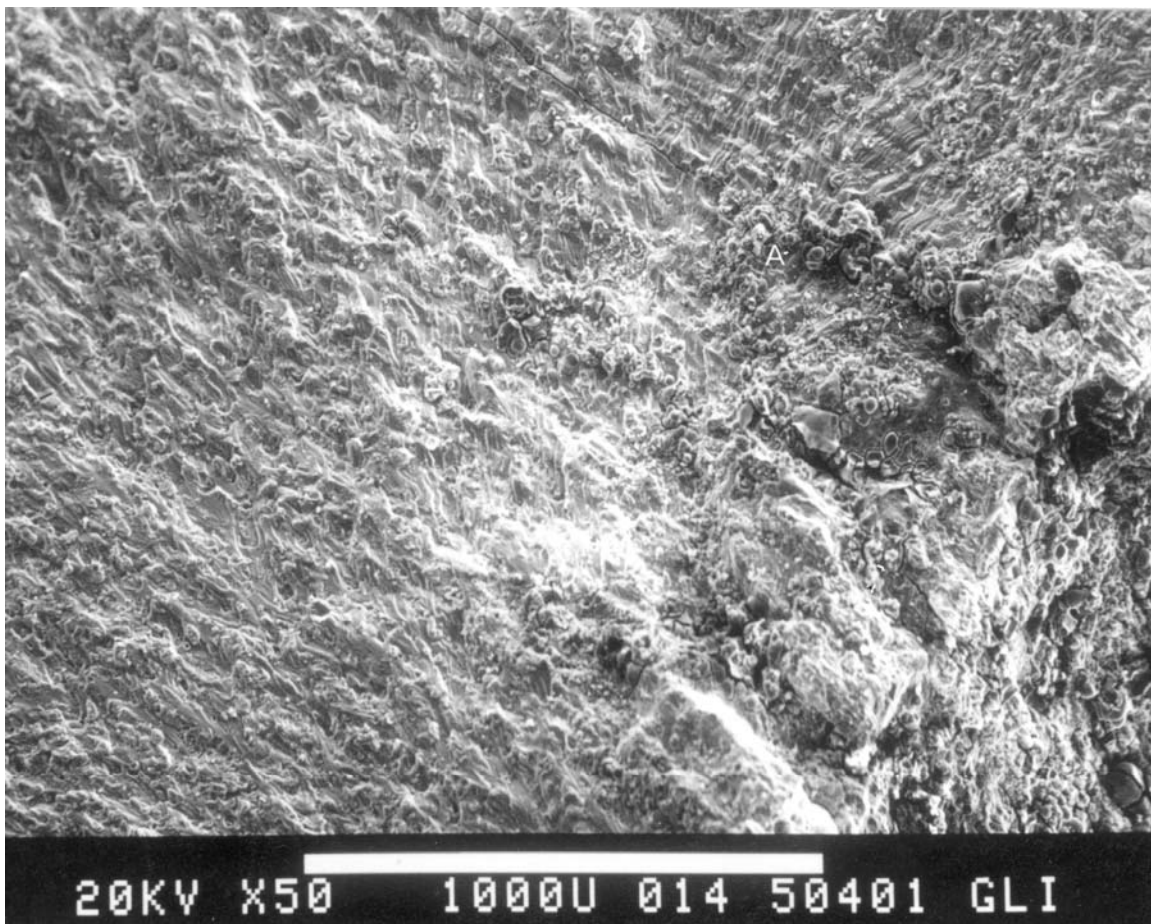
**Figure 70. SEM of Fracture Surface of Alloy 7075-T6 ECT Specimen Precorroded in the EXCO Solution for 2 Days and Fatigued in Laboratory Air (5 Hz, R=0.1); Exfoliation Corrosion is Seen on the Right Side of the Micrograph**

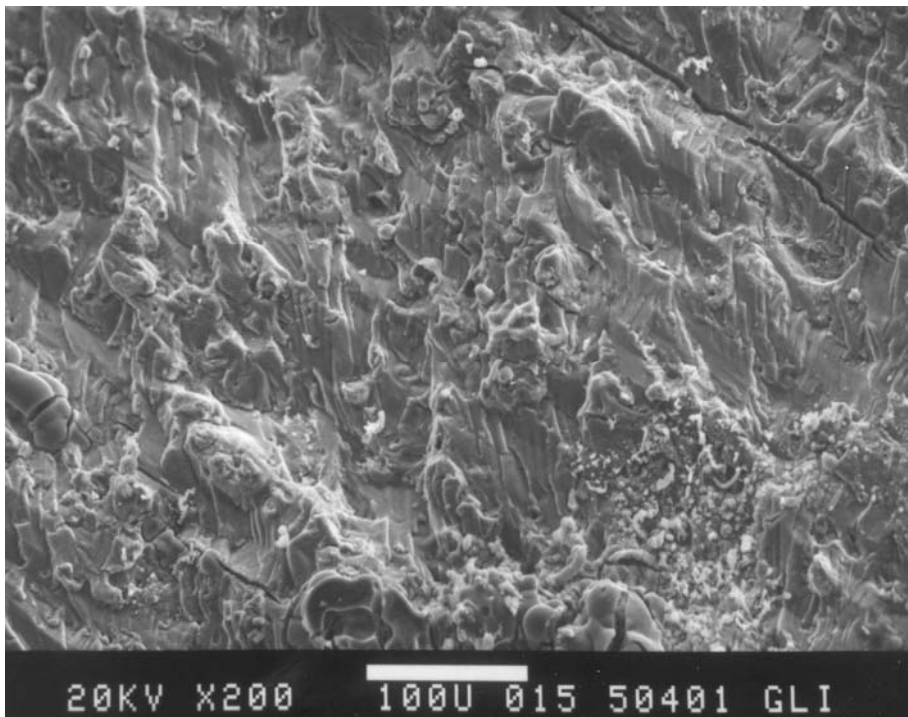
**Figure 71. Detail A in Figure 70 Showing Secondary Crack**

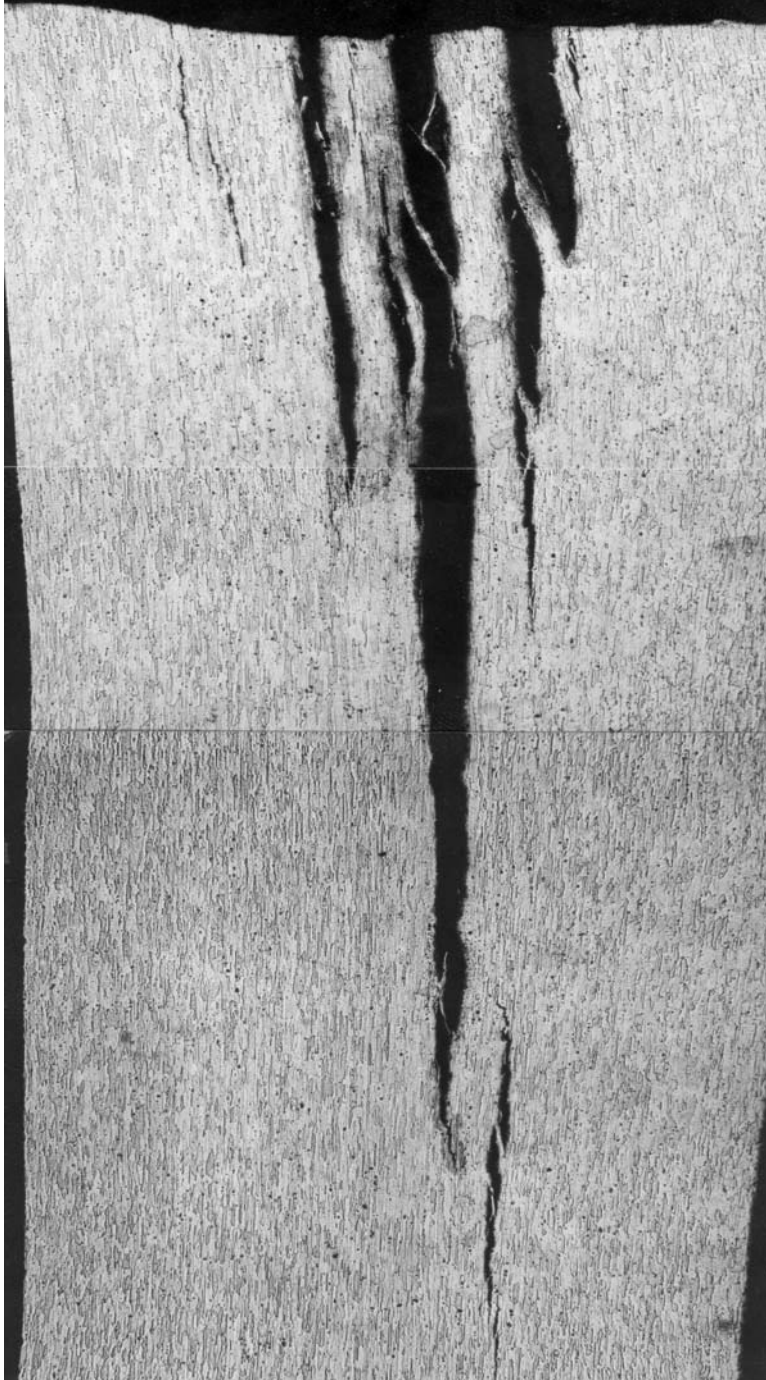
**Figure 73. Optical Micrograph of Metallographic Cross Section Across the Secondary Crack Shown in Figures 71 and 72**

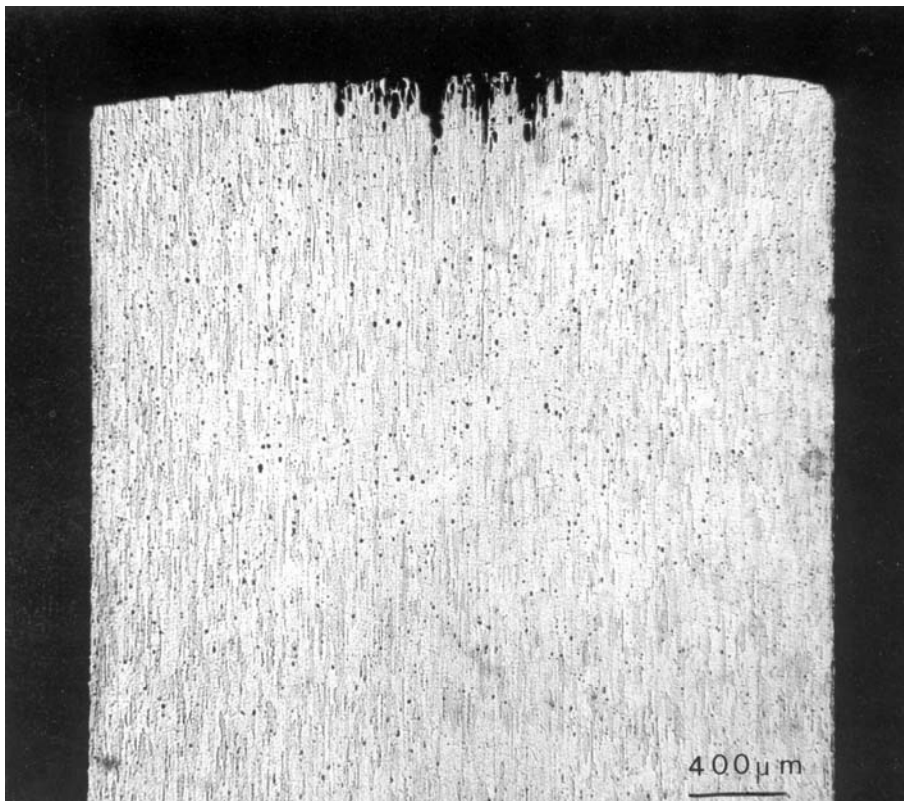
**Figure 74. Optical Micrograph of Metallographic Cross Section through the Thickness of an Aluminum Alloy 7075-T6 ECT Specimen Exposed to the EXCO Solution for 2 Days**

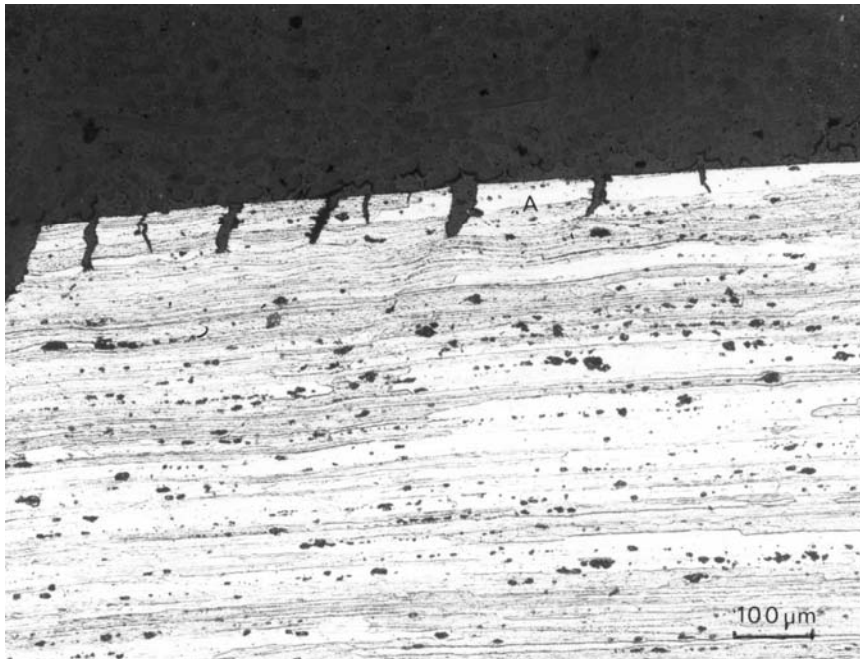
**Figure 79. Optical Micrograph of Metallographic Cross Section through Gage Length of Specimen Shown in Figure 76, Showing Extensive Secondary Cracking**

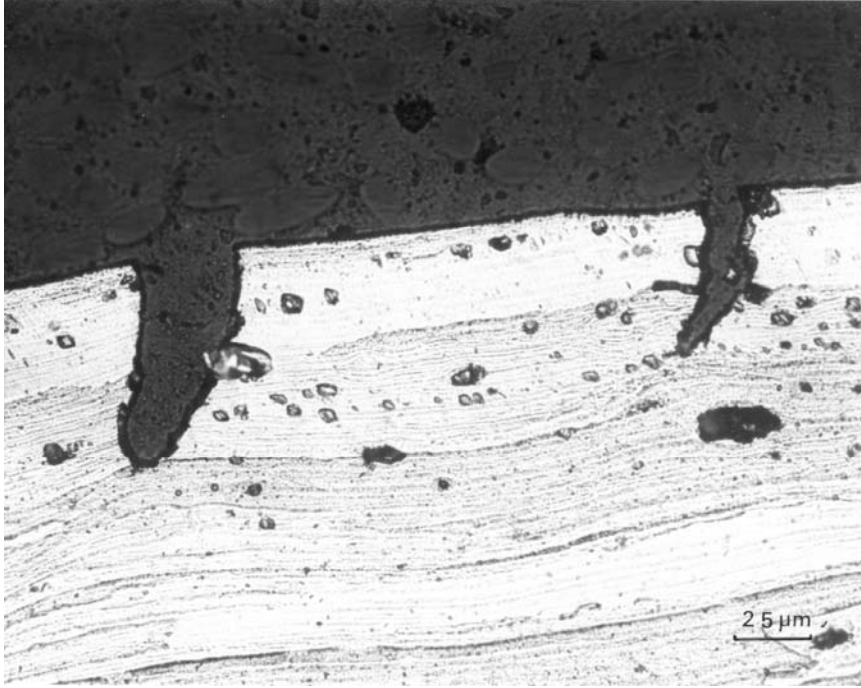
**Figure 80. Detail of Area A in Figure 79 Showing Transgranular Secondary Cracking, as Well as Intergranular Attack**

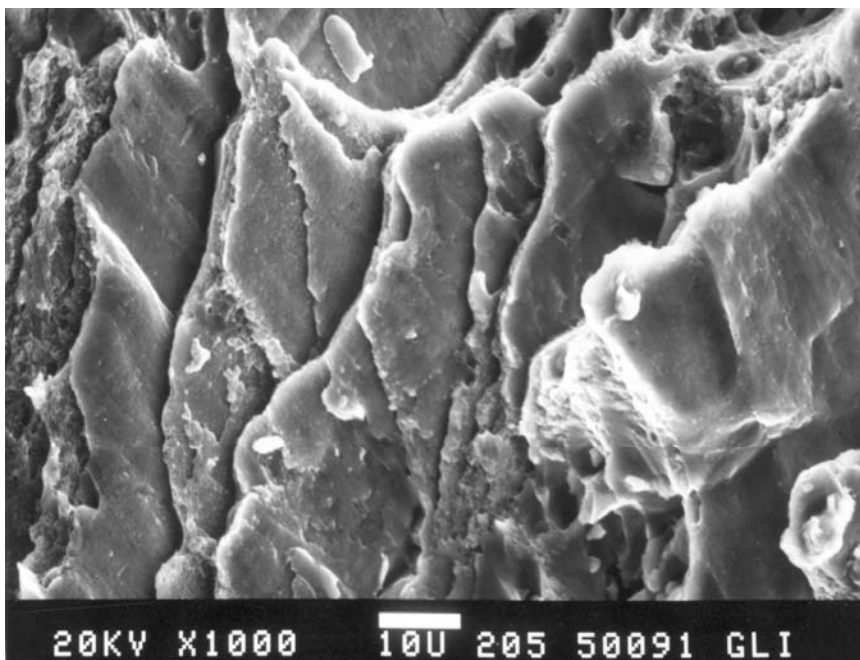
**Figure 84. Detail of A in Figure 83 Showing Extensive Intergranular Fracture**

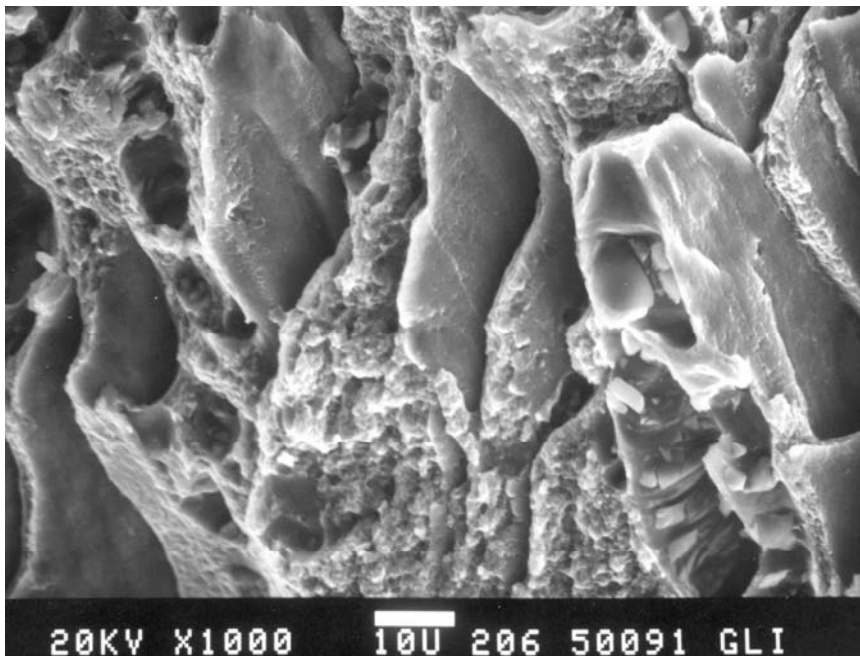
**Figure 85. Detail of Area B in Figure 83 Showing Extensive Intergranular Fracture**

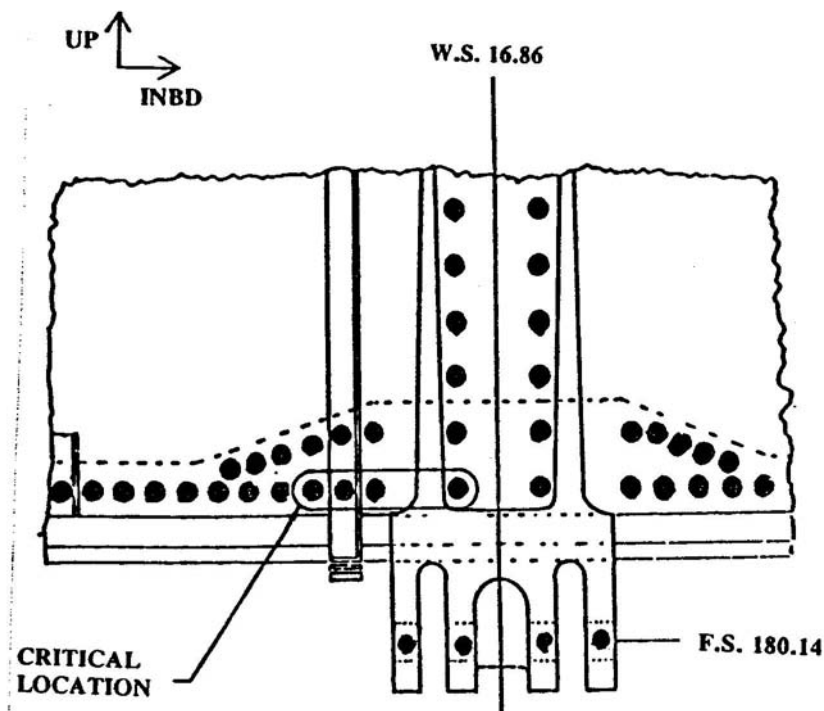
**Figure 87. Critical Location at Wing Lower Front Spar Vertical Flange**

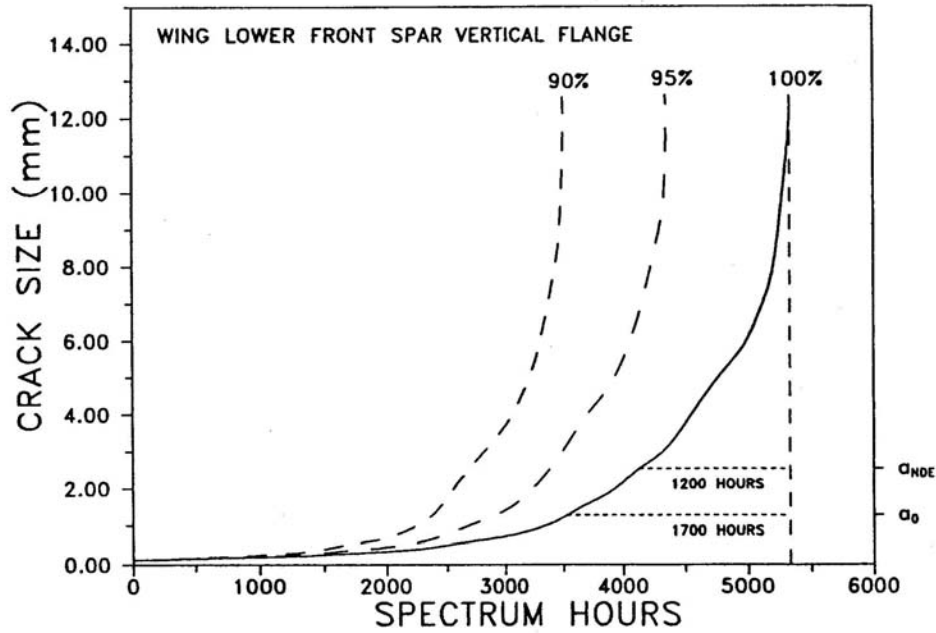
**Figure 88. Crack Growth Life Curves for Critical Location at Wing Lower Front Spar Vertical Flange**

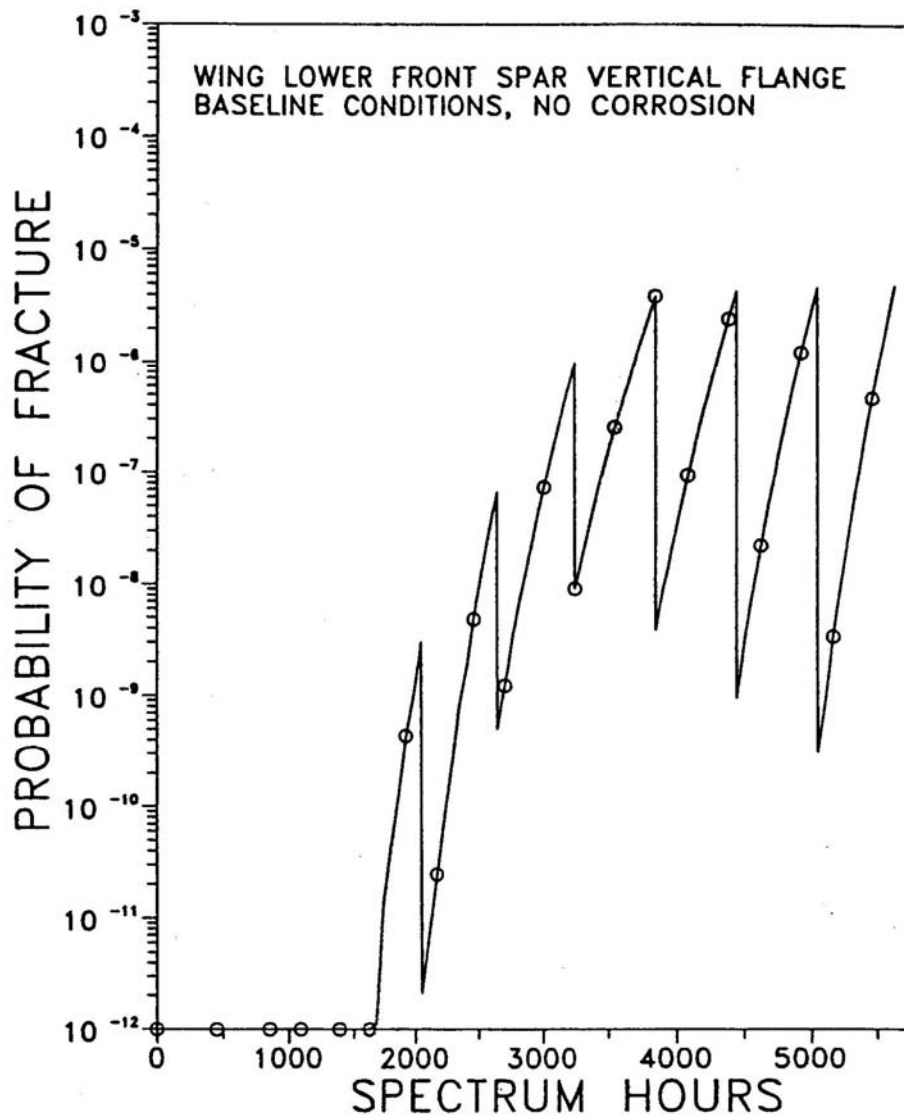
**Figure 89. Fracture Risks for Baseline Conditions**

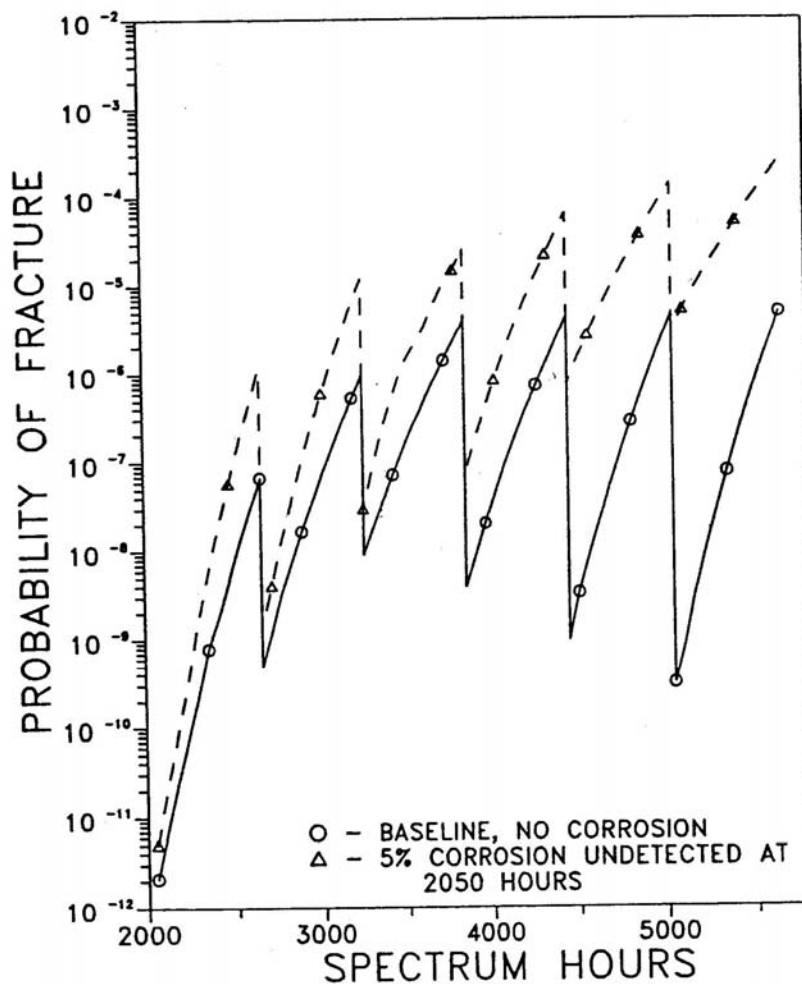
**Figure 91. Fracture Risks for Baseline Conditions and 5 Percent Corrosion Undetected at 2,050 Hours**

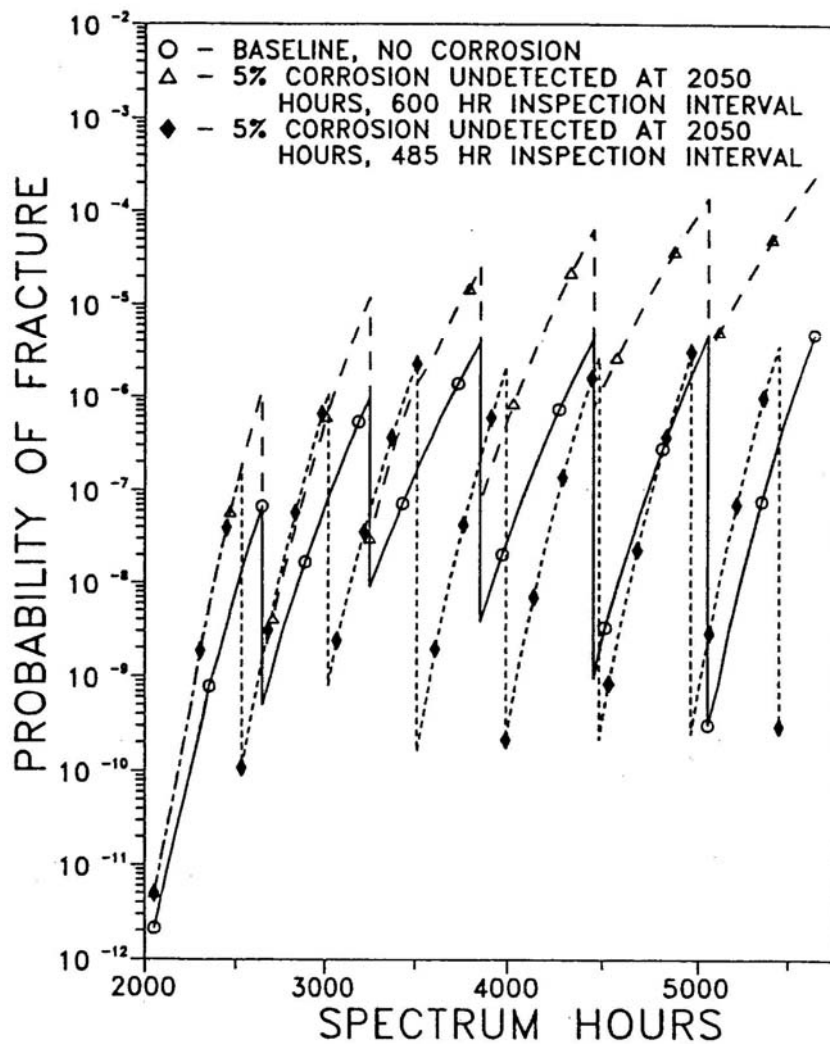
**Figure 92. Fracture Risks for Baseline Conditions and 5 Percent Corrosion Undetected at 2,050 Hours - Two Inspection Intervals**

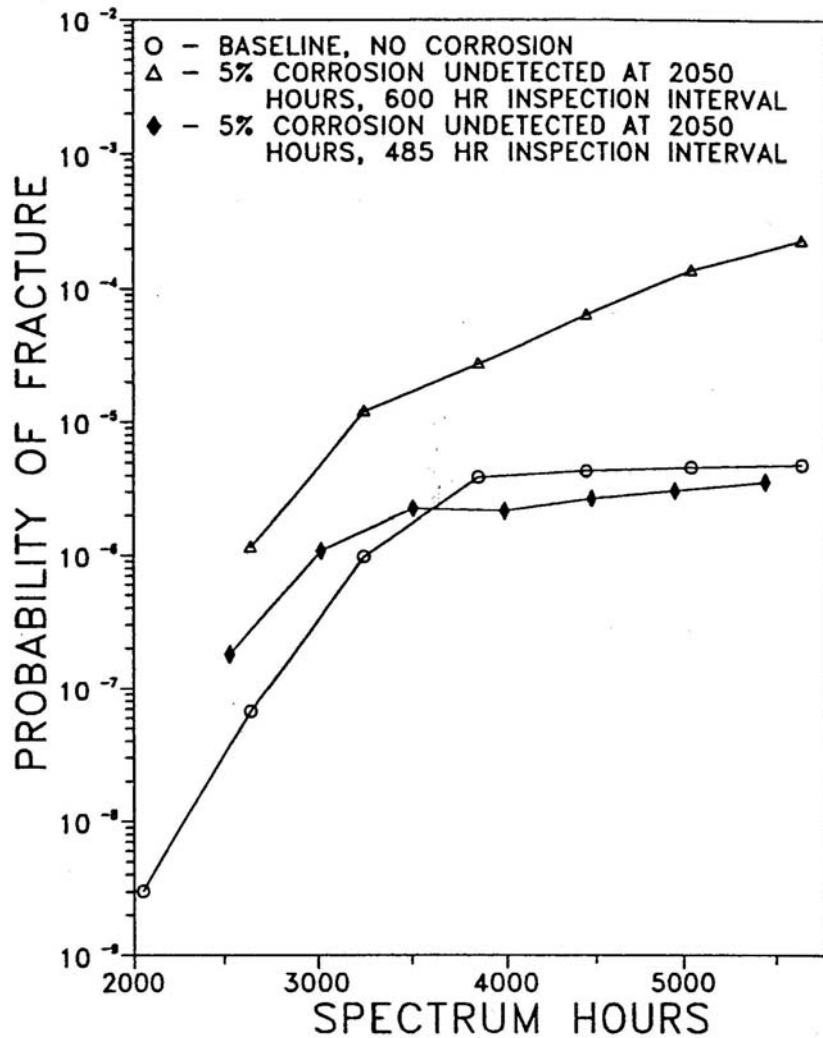
**Figure 93. Maximum Fracture Risks per Interval, Baseline Conditions and 5 Percent Corrosion Undetected at 2,050 Hours - Two Inspection Intervals**

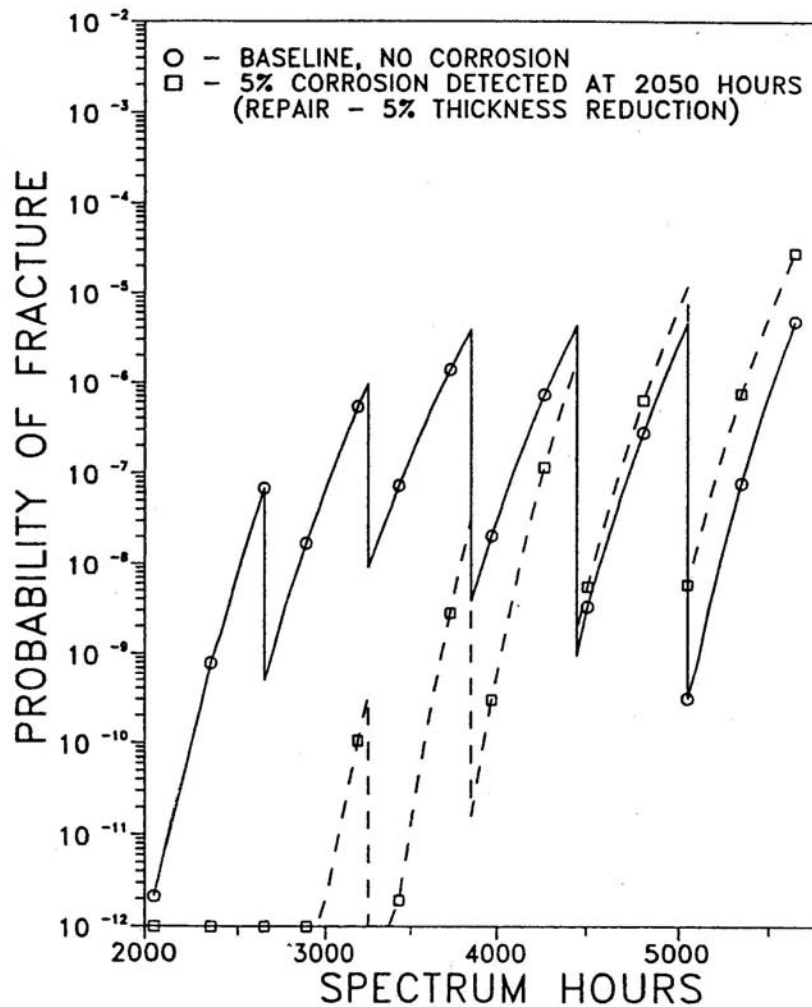
**Figure 94. Fracture Risks for Baseline Conditions and 5 Percent Corrosion Detected at 2,050 Hours**

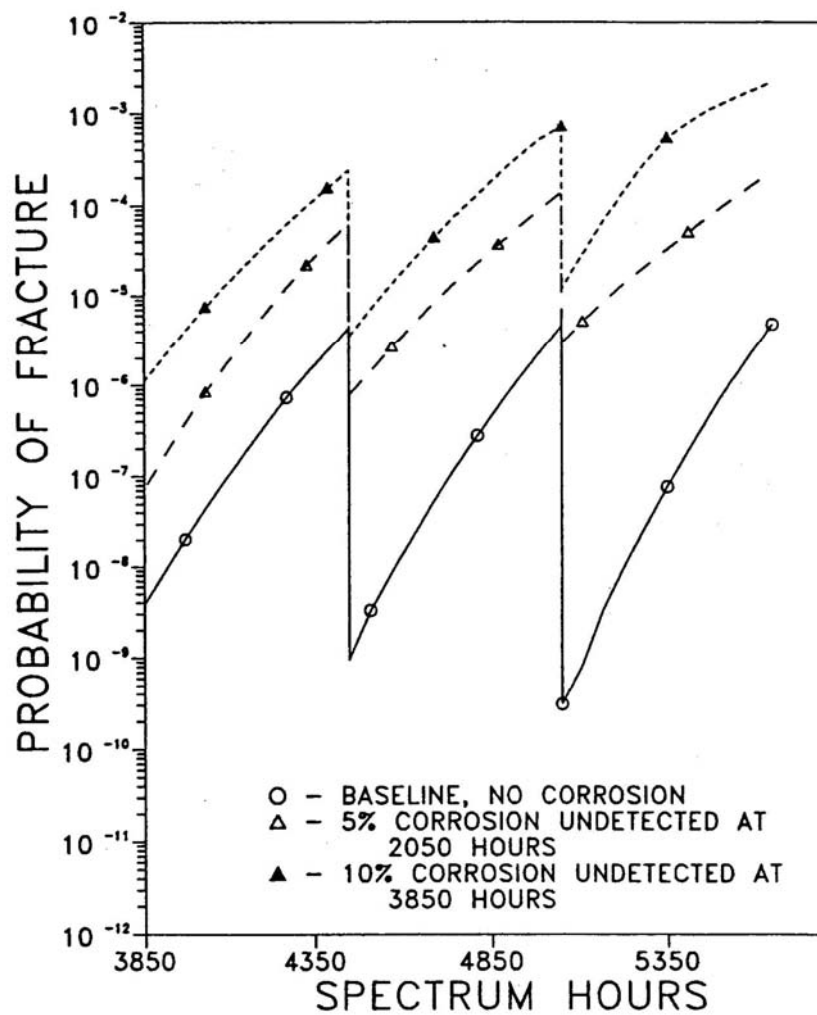
Figure 95. Fracture Risks for Baseline Conditions, 5 Percent Corrosion Undetected at 2,050 Hours, and 5 Percent More Corrosion Undetected at 3,850 Hours

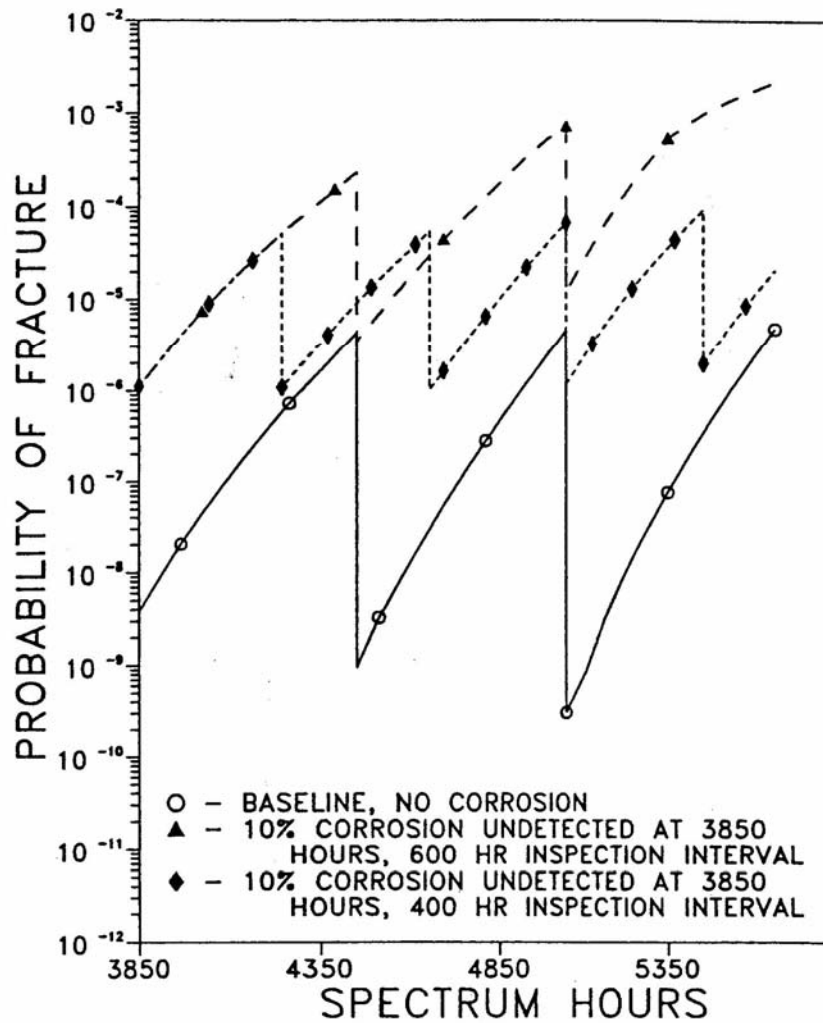
Figure 96. Fracture Risks for Baseline Conditions, 5 Percent Corrosion Undetected at 2,050 Hours, and 5 Percent More Corrosion Undetected at 3,850 Hours - Two Inspection Intervals

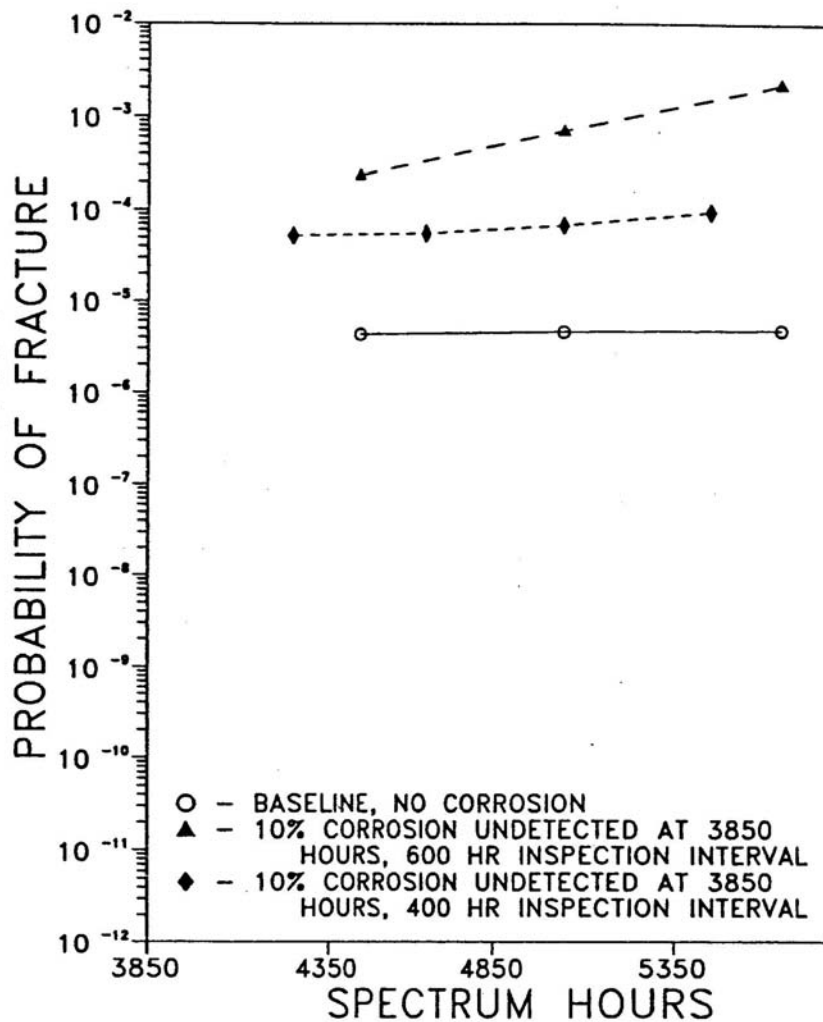
**Figure 97. Maximum Fracture Risks Per Interval, 5 Percent Corrosion Undetected at 2,050 Hours, and 5 Percent More Corrosion Undetected at 3,850 Hours - Two Inspection Intervals**

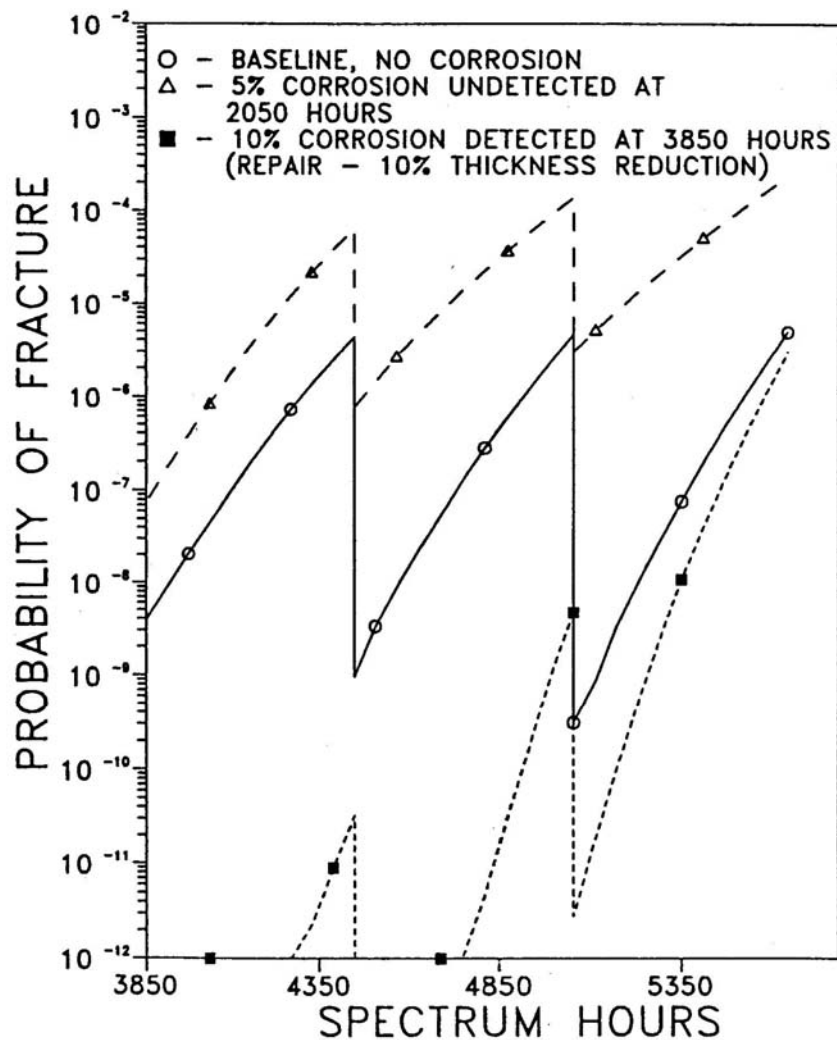
**Figure 98. Fracture Risks for Baseline Conditions, 5 Percent Corrosion Undetected at 2,050 Hours, and 10 Percent Corrosion Detected at 3,850 Hours**

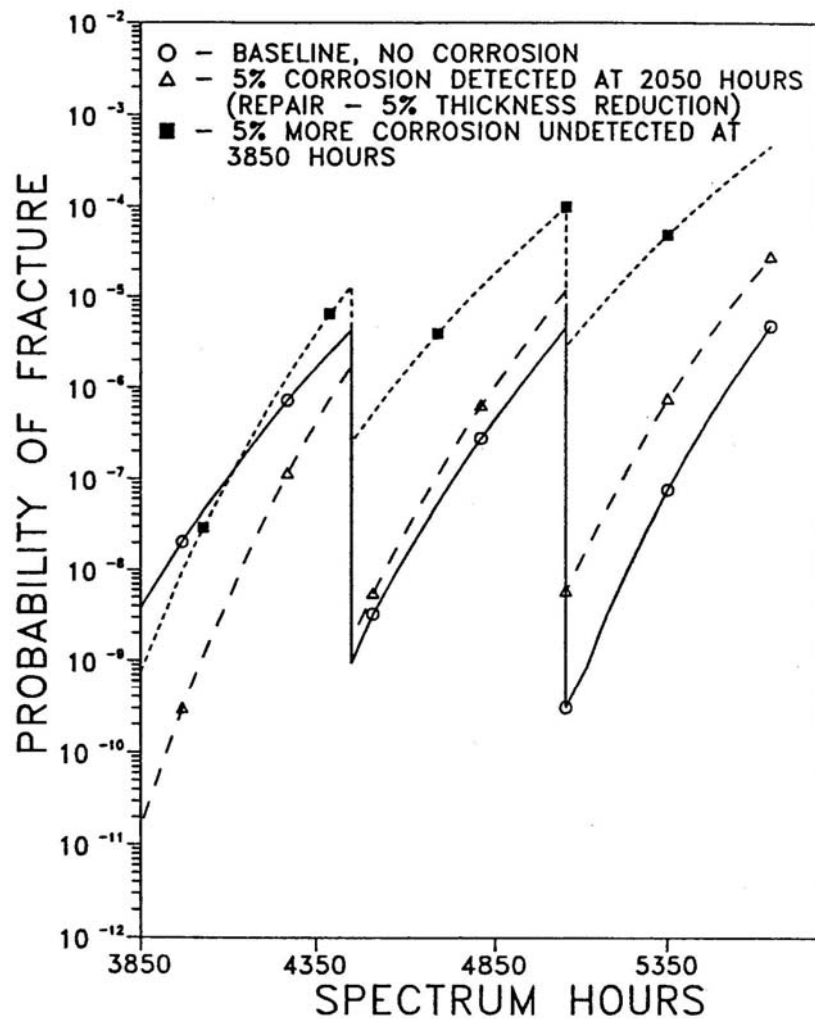
**Figure 99. Fracture Risks for Baseline Conditions, 5 Percent Corrosion Detected at 2,050 Hours, and 5 Percent More Corrosion Undetected at 3,850 Hours**

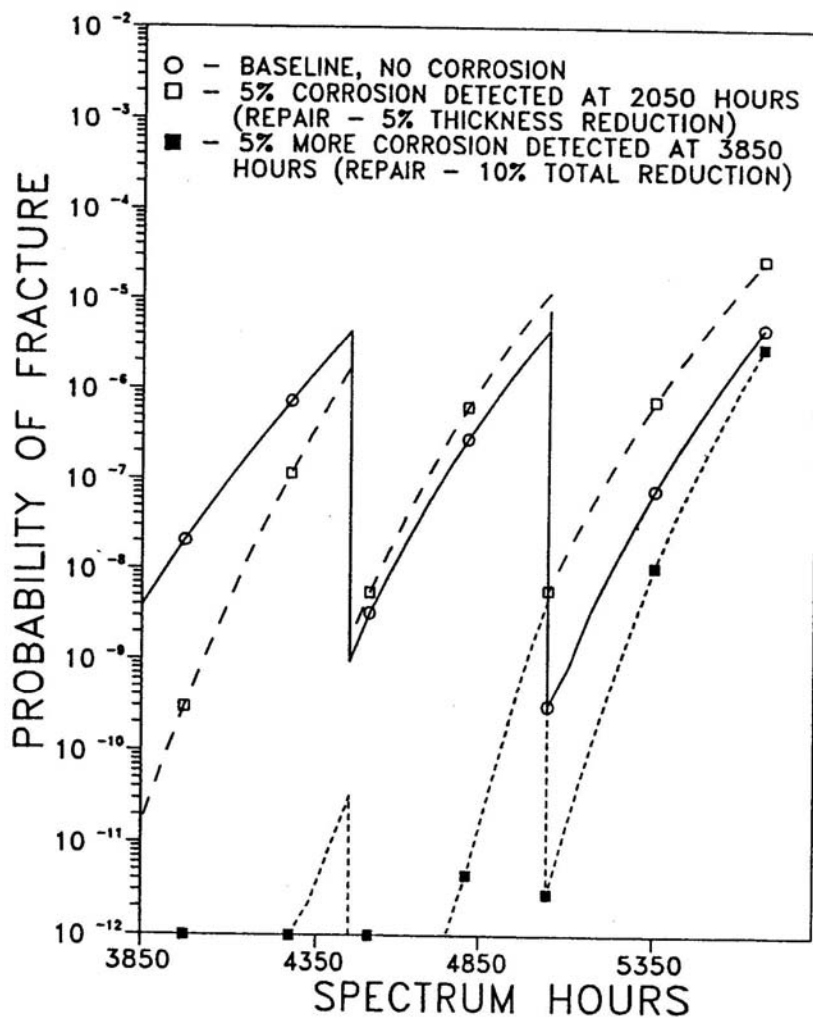
**Figure 100. Fracture Risks for Baseline Conditions, 5 Percent Corrosion Detected at 2,050 Hours, and 5 Percent More Corrosion Detected at 3,850 Hours**

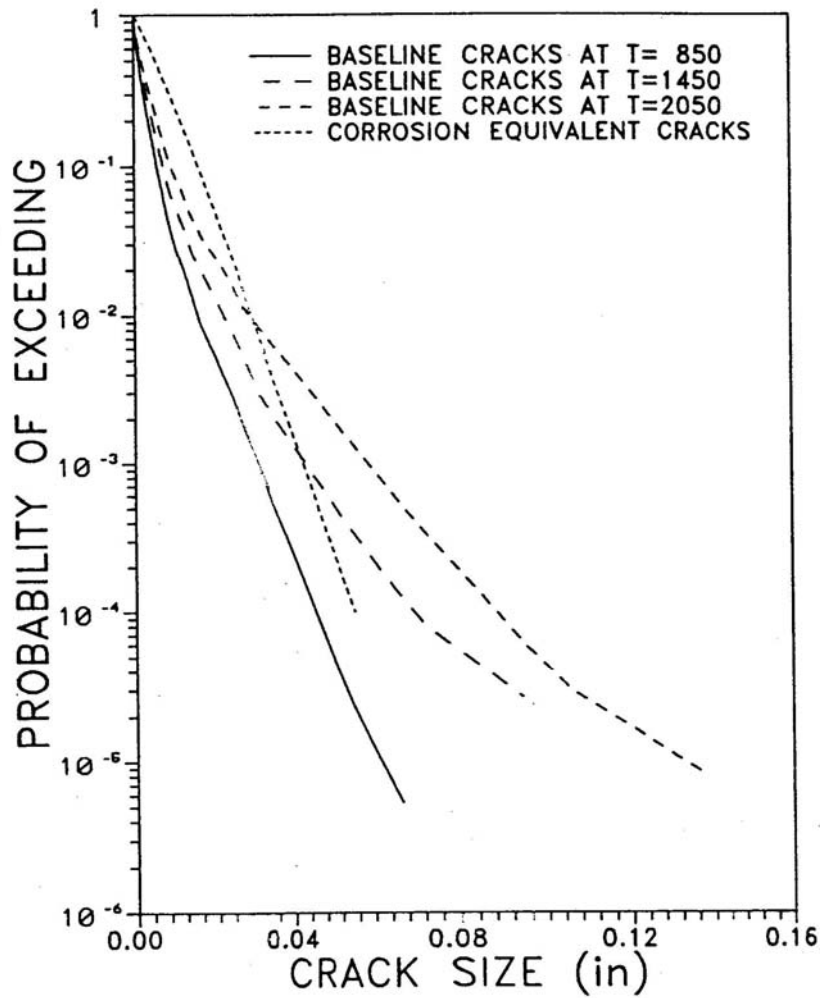
**Figure 101. Comparison of Corrosion Equivalent Crack Size Distribution with Distributions of Growing Equivalent Initial Crack Size Distributions**
